DATA SHEETS

'M' MOULDS

REPAIR MANUAL

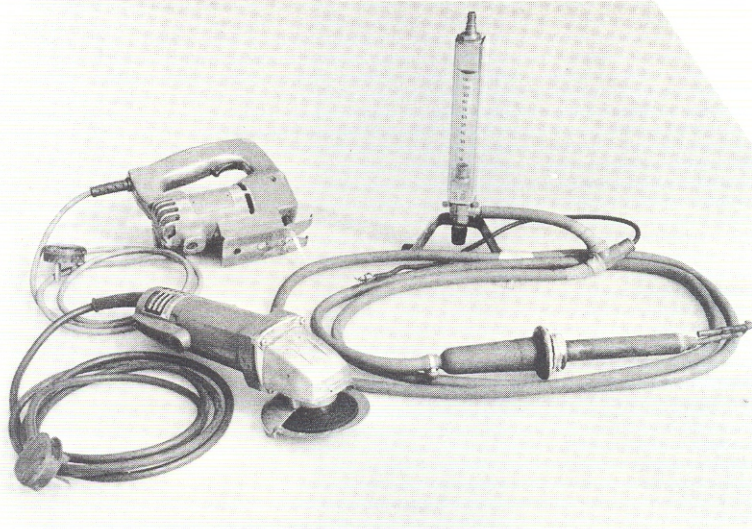
Fig. 1

Equipment Required for Repairing

1. Plastic welding kit, gun, etc. obtainable from :-

2. Polisher.
3. Jig-Saw.
4. Polypropylene Sheet.
5. Plastic Welding Rod. (Not shown).
6. Reciprocator/Compressor. (Not shown).

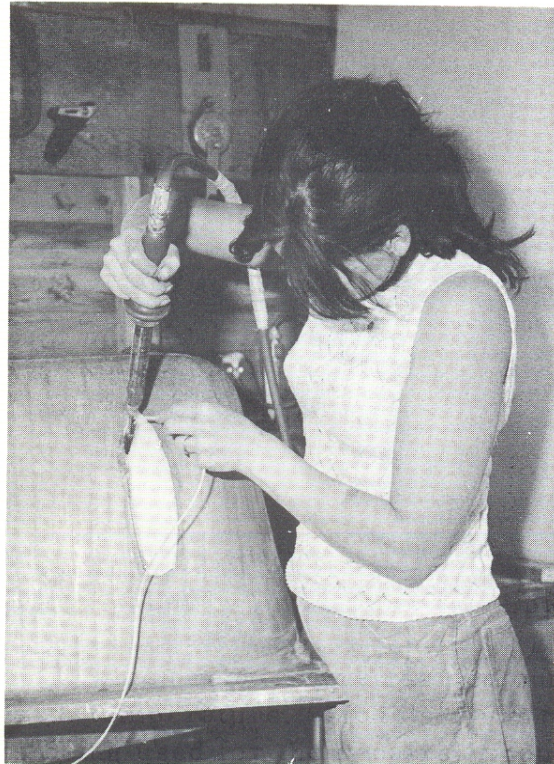
Fig. 2

First a piece of material is cut from the polypropylene sheet to approximately the same shape as the missing section. This should be slightly smaller than the hole itself to allow for the weld. The replacement piece of material is inserted and held in position with a clamp from the inside. The welding process is then carried out as in Fig. 2. (The welding rod used can be seen being fed into the welding gun.)

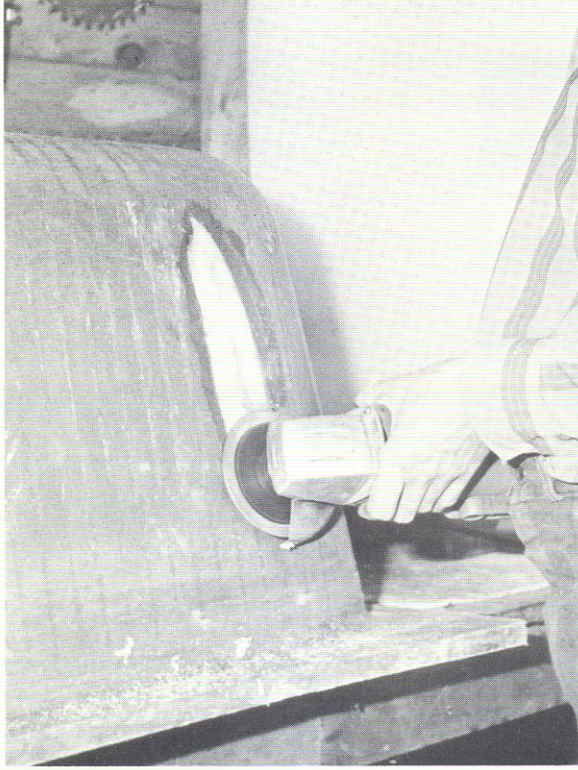
Fig. 3

The polisher is then used from the outside to smooth the repair to the same plane as the mould, (see Fig. 3) and the excess patch removed from the inside.

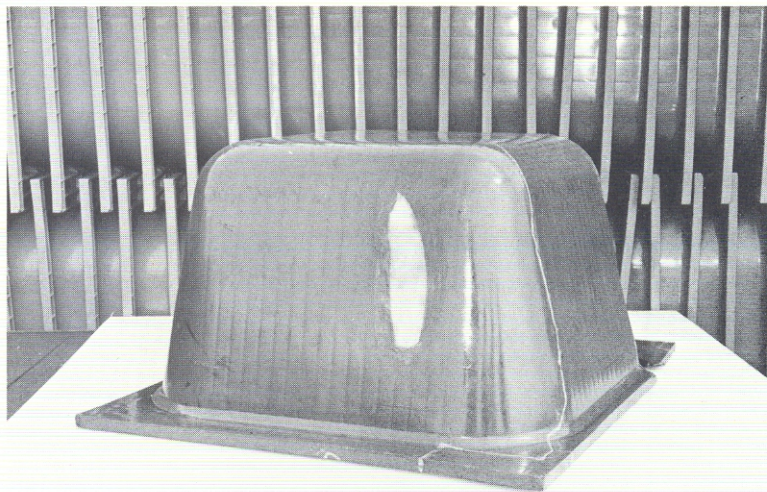
Fig. 4

The result is as seen in Fig. 4.

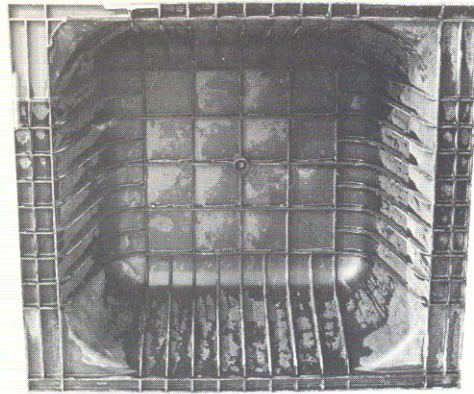
Fig. 7

The completed repair showing the position of the splints is illustrated in Fig. 7.
